INSPECTION

In May 2013 a routine water fittings inspection of a primary school found the installation of a rainwater harvesting system (RWH) used to store and provide water to all the schools toilet flushing cisterns. The RWH cistern also received mains water back up supply via a tundish incorporating a type AA air gap to replenish the storage cistern in dry weather.

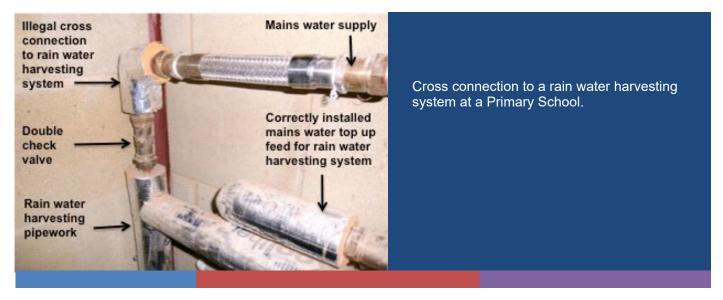
On inspection it was noted that this perfectly acceptable arrangement was bypassed and an illegal direct connection made to the public water supply. This meant a risk of the contents of the RWH cistern entering the public and the schools drinking water supply under certain conditions. The company's regulation officer identified the risk and served a formal notice to remove the illegal cross connection.

operating cost of the RWH pump. The school was advised to remove the mains water backup supply and replace the pump with a dual pump to help prevent future loss of supply should the single pump fail.

The follow up inspection confirmed the school had followed the water company's advice and replaced the single pump with a dual pump set and completed the remediation work in compliance with Water Fittings Regulations.
